**Flood Control Project Maintenance  
Levee Inspections**  
**LMA District Cover Sheet**  
**Spring 2018 Levee Inspection Results**

**Reclamation District No. 2068 Yolano**

**Levee Inspection Report By Mile - Spring 2018**

Waterway	Bank	Unit Miles	Inspection Start/End	Inspector
Unit No. 01 Yolo Bypass	Right	5.48	03/15/2018 03/15/2018	Keith Millard

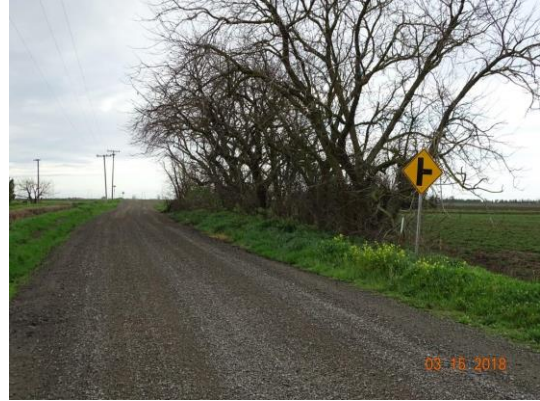
Photo 1 of 1 : SP\_2018\_RD2068\_193\_15\_20180315\_00043.jpg

LM Start	0.40	Rating **	M	Issue No.	15
LM End	0.40	Issue Type +	Ma	Location *	LS
Category	Earthen Levee			GPS Latitude/Longitude	
				Start	End
Item	Trim / Thin Trees			38.402705 °	38.402705 °
				-121.693790 °	-121.693787 °
DWR ID	DWR_RD2068_01_s_2017_15				
Comment Code					
T1 : Trim trees to at least five feet above ground level.					
Inspector Comment					
Trim the tree on the landside shoulder levee mile 0.40.

Trim trees to allow inspection and access to landside slope and toe.

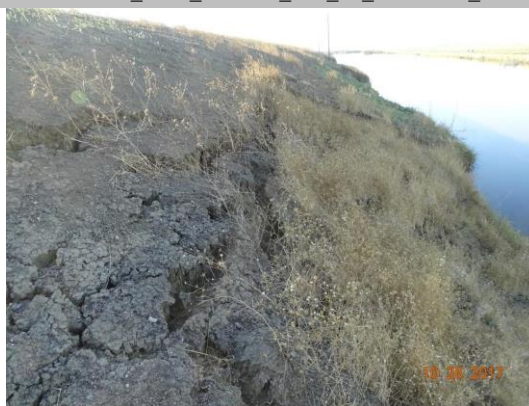
Photo 2 of 2 : SP\_2018\_RD2068\_193\_20\_20180305\_00012.jpg

LM Start	3.16	Rating **	A/W	Issue No.	20 (cont)	
LM End	3.19	Issue Type +	Ma	Location *	LS	
Category	Earthen Levee			GPS Latitude/Longitude		
				Start		End
Item	Slope Stability			38.362765 °		38.362278 °
				-121.694040 °		-121.694050 °
DWR ID	DWR_RD2068_01_s_2017_20					
Comment Code						
S1 : Repair slope instability.						
Inspector Comment						
Repair the slope instability.

Repair the slope instability.

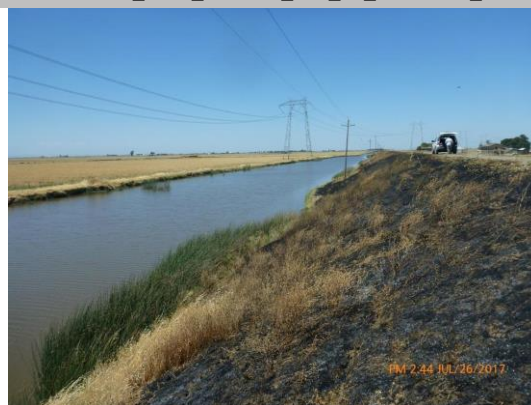
Photo 1 of 3 : SP\_2018\_RD2068\_193\_16\_20180305\_00001.jpg

LM Start	3.30	Rating **	A/W	Issue No.	16
LM End	3.31	Issue Type +	Ma	Location *	
Category	Supplemental			GPS Latitude/Longitude	
				Start	End
Item	2017 Storm Damage			38.360700 °	38.360600 °
				-121.694200 °	-121.694200 °
DWR ID	DWR_RD2068_01_f_2017_16				
Comment Code					
Inspector Comment					
Levee Evaluation Comments					
Description:The damage consists of scour, cracking, and sloughing of the lower and mid landside levee slope approximately 39 feet in length along the west (right) bank of Shag Slough (Yolo Bypass). See attached pages for photos.					
Site ID No:457					
Site Designation:LMA-284					
Repair Type: Stability					
Rating:Serious					
Field Date:7/26/2017					
Notes: combined with LMA-283. Combined site length 430'.

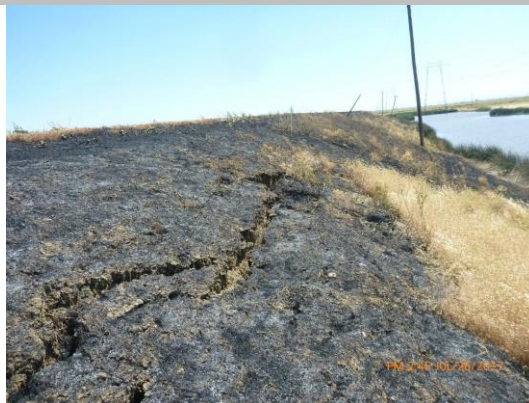
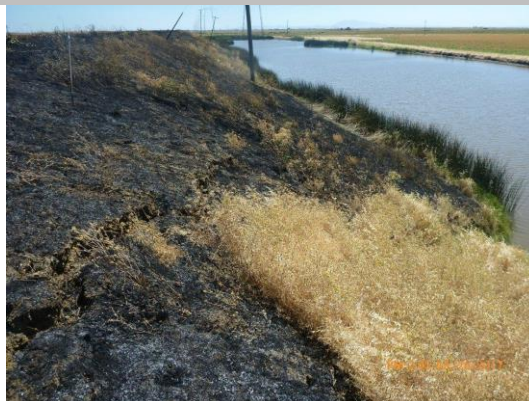
LM Start	3.30	Rating **	A/W	Issue No.	16 (cont)	
LM End	3.31	Issue Type +	Ma	Location *		
Category	Supplemental			GPS Latitude/Longitude		
				Start	End	
Item	2017 Storm Damage			38.360700 °	38.360600 °	
				-121.694200 °	-121.694200 °	
DWR ID	DWR_RD2068_01_f_2017_16					
Comment Code						
Inspector Comment						
Levee Evaluation Comments						
Description:The damage consists of scour, cracking, and sloughing of the lower and mid landside levee slope approximately 39 feet in length along the west (right) bank of Shag Slough (Yolo Bypass). See attached pages for photos.						
Site ID No:457						
Site Designation:LMA-284						
Repair Type: Stability						
Rating:Serious						
Field Date:7/26/2017						
Notes: combined with LMA-283. Combined site length 430'.

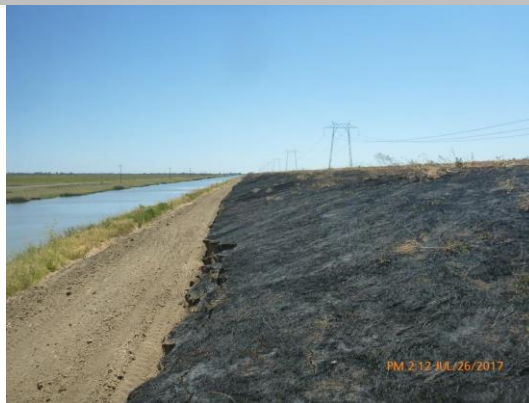
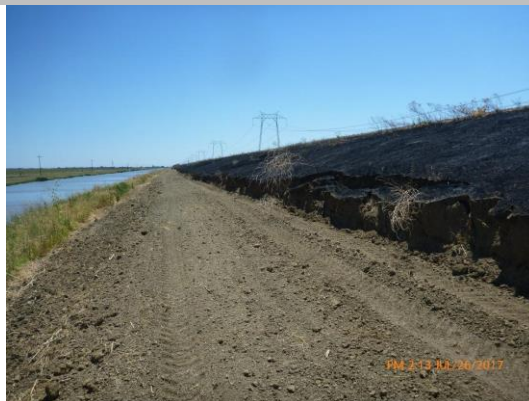
LM Start	3.36	Rating **	A/W	Issue No.	17
LM End	5.23	Issue Type +	Ma	Location *	WS
Category	Supplemental			GPS Latitude/Longitude	
				Start	End
Item	2017 Storm Damage			38.359900 °	38.332700 °
				-121.693800 °	-121.693700 °
DWR ID	DWR_RD2068_01_f_2017_17				
Comment Code					
Inspector Comment					
Levee Evaluation Comments					
Description:The damage consists of scour and sloughing of the lower waterside levee slope approximately 9,950 feet in length along the west (right) bank of Shag Slough (Yolo Bypass). See attached pages for photos.					
Site ID No:459					
Site Designation:LMA-286					
Repair Type: Stability					
Rating:Area of Concern					
Field Date:7/26/2017					
Notes:

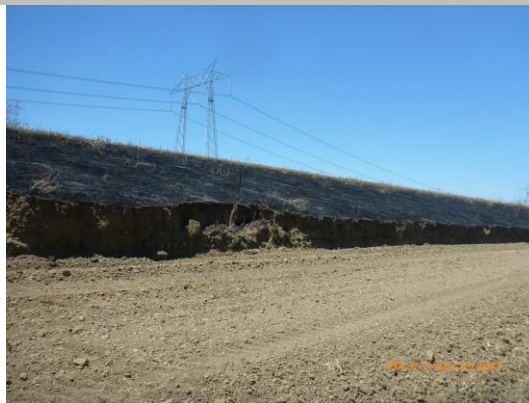
Photo 3 of 3 : SP\_2018\_RD2068\_193\_17\_20180305\_00006.jpg

LM Start	<b>3.36</b>	Rating **	A/W	Issue No.	<b>17 (cont)</b>
LM End	<b>5.23</b>	Issue Type +	Ma	Location *	WS
Category	Supplemental			GPS Latitude/Longitude	
				Start	End
Item	2017 Storm Damage			38.359900 °	38.332700 °
				-121.693800 °	-121.693700 °
DWR ID	DWR_RD2068_01_f_2017_17				
Comment Code					
Inspector Comment					
Levee Evaluation Comments Description: The damage consists of scour and sloughing of the lower waterside levee slope approximately 9,950 feet in length along the west (right) bank of Shag Slough (Yolo Bypass). See attached pages for photos. Site ID No: 459 Site Designation: LMA-286 Repair Type: Stability Rating: Area of Concern Field Date: 7/26/2017 Notes:

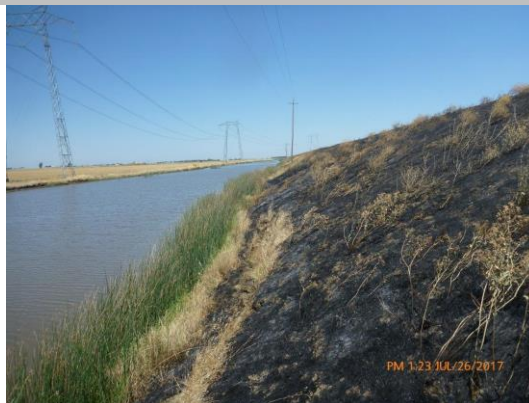
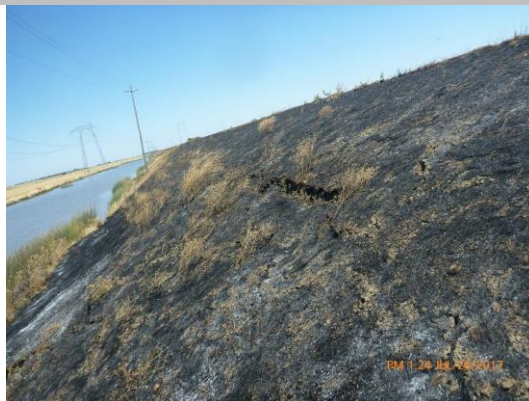
LM Start	3.38	Rating **	A/W	Issue No.	18
LM End	3.39	Issue Type +	Ma	Location *	
Category	Supplemental			GPS Latitude/Longitude	
				Start	End
Item	2017 Storm Damage			38.359500 °	38.359400 °
				-121.694200 °	-121.694200 °
DWR ID	DWR_RD2068_01_f_2017_18				
Comment Code					
Inspector Comment					
Levee Evaluation Comments					
Description:The damage consists of scour of the lower landside levee slope approximately 32 feet in length along the west (right) bank of Shag Slough (Yolo Bypass). See attached pages for photos.					
Site ID No:460					
Site Designation:LMA-287					
Repair Type: Stability					
Rating:Serious					
Field Date:7/26/2017					
Notes: levee slope is heavily impacted from deep slope cracks and lack of levee slope support from the toe

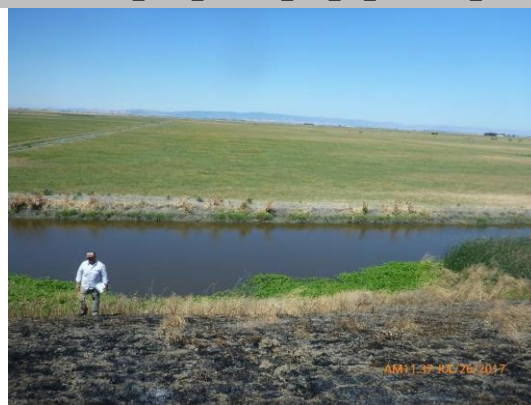
Photo 1 of 3 : SP\_2018\_RD2068\_193\_28\_20180305\_00016.jpg

LM Start	4.30	Rating **	A/W	Issue No.	28
LM End	4.31	Issue Type +	Ma	Location *	
Category	Supplemental			GPS Latitude/Longitude	
				Start	End
Item	2017 Storm Damage			38.346200 °	38.346100 °
				-121.694000 °	-121.694000 °
DWR ID	DWR_RD2068_01_f_2017_28				
Comment Code					
Inspector Comment					
Levee Evaluation Comments					
Description:The damage consists of scour, cracking, and sloughing of the lower landside levee slope approximately 30 feet in length along the west (right) bank of Shag Slough (Yolo Bypass). See attached pages for photos.					
Site ID No:463					
Site Designation:LMA-290					
Repair Type: Stability					
Rating:Serious					
Field Date:7/26/2017					
Notes: 3' feet vertical cut at waterside levee toe from wavewash

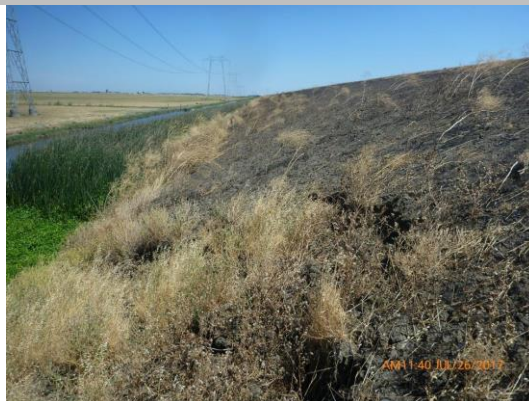
LM Start	4.30	Rating **	A/W	Issue No.	28 (cont)	
LM End	4.31	Issue Type +	Ma	Location *		
Category	Supplemental			GPS Latitude/Longitude		
				Start	End	
Item	2017 Storm Damage			38.346200 °	38.346100 °	
				-121.694000 °	-121.694000 °	
DWR ID	DWR_RD2068_01_f_2017_28					
Comment Code						
Inspector Comment						
Levee Evaluation Comments						
Description:The damage consists of scour, cracking, and sloughing of the lower landside levee slope approximately 30 feet in length along the west (right) bank of Shag Slough (Yolo Bypass). See attached pages for photos.						
Site ID No:463						
Site Designation:LMA-290						
Repair Type: Stability						
Rating:Serious						
Field Date:7/26/2017						
Notes: 3' feet vertical cut at waterside levee toe from wavewash

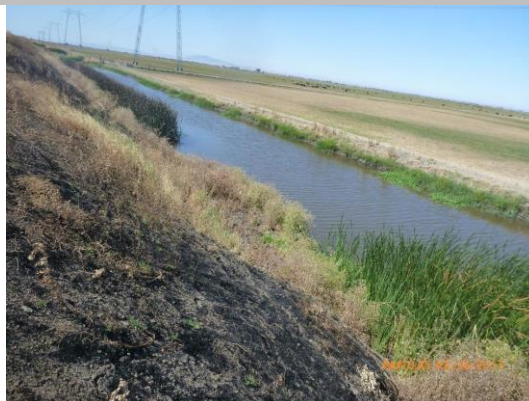
LM Start	4.39	Rating **	A/W	Issue No.	29
LM End	4.40	Issue Type +	Ma	Location *	
Category	Supplemental			GPS Latitude/Longitude	
				Start	End
Item	2017 Storm Damage			38.344900 °	38.344800 °
				-121.694000 °	-121.694000 °
DWR ID	DWR_RD2068_01_f_2017_29				
Comment Code					
Inspector Comment					
Levee Evaluation Comments					
Description:The damage consists of scour, cracking, and sloughing of the lower landside levee slope approximately 30 feet in length along the west (right) bank of Shag Slough (Yolo Bypass). See attached pages for photos.					
Site ID No:464					
Site Designation:LMA-291					
Repair Type: Stability					
Rating:Serious					
Field Date:7/26/2017					
Notes: 2' feet vertical cut at waterside levee toe from wavewash

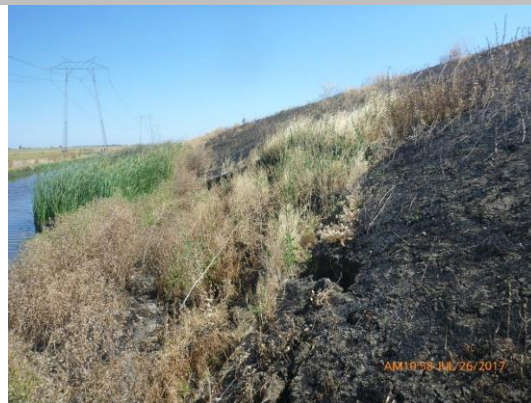
Photo 3 of 3 : SP\_2018\_RD2068\_193\_29\_20180305\_00021.jpg

LM Start	4.39	Rating **	A/W	Issue No.	29 (cont)	
LM End	4.40	Issue Type +	Ma	Location *		
Category	Supplemental			GPS Latitude/Longitude		
				Start	End	
Item	2017 Storm Damage			38.344900 °	38.344800 °	
				-121.694000 °	-121.694000 °	
DWR ID	DWR_RD2068_01_f_2017_29					
Comment Code						
Inspector Comment						
Levee Evaluation Comments						
Description:The damage consists of scour, cracking, and sloughing of the lower landside levee slope approximately 30 feet in length along the west (right) bank of Shag Slough (Yolo Bypass). See attached pages for photos.						
Site ID No:464						
Site Designation:LMA-291						
Repair Type: Stability						
Rating:Serious						
Field Date:7/26/2017						
Notes: 2' feet vertical cut at waterside levee toe from wavewash

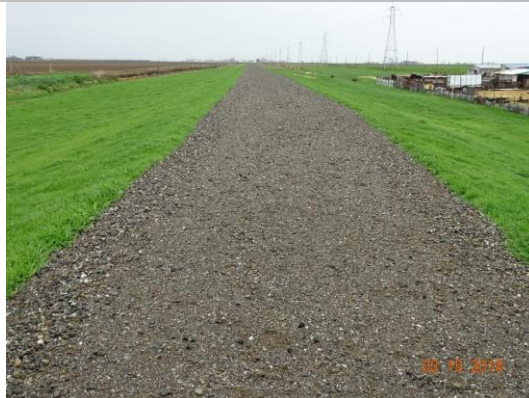
Photo 1 of 1 : SP\_2018\_RD2068\_194\_11\_20180315\_00012.jpg

LM Start	0.01	Rating **	A/W	Issue No.	11
LM End	1.85	Issue Type +	Ma	Location *	CR
Category	Earthen Levee			GPS Latitude/Longitude	
				Start	End
Item	Vegetation			38.358313 °	38.382542 °
				-121.740385 °	-121.730262 °
DWR ID	DWR_RD2068_02_s_2017_11				
Comment Code					
V9 : Keep the crown roadway free of vegetation.					
Inspector Comment					
Crown is free of vegetation.

Lack of crown vegetation looking north from LM 1.02.

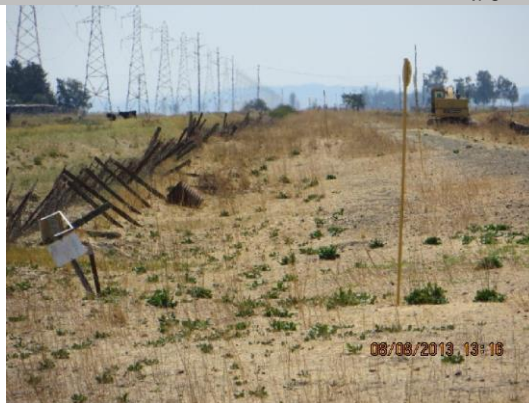
Photo 1 of 2 : UCIP\_SP\_2018\_17531\_29641.jpg

LM Start	0.91	Rating **	M	Issue No.	21	
LM End	0.91	Issue Type +	En	Location *		
Category	Supplemental			GPS Latitude/Longitude		
				Start	End	
Item	DWR UCIP Field Study			38.371273 °	38.371273 °	
				-121.740138 °	-121.740138 °	
DWR ID						
Comment Code						
Inspector Comment						
FS_ID:17531 DS_ID:19355 EP_NO: 8151 Repair Type: Non-Urgent Crossing Status: Indicator Found UCIP Comments: Appears abandoned. Need to verify with pipeline owner. FIELD_STRUCT_DESC: 8-inch coated steel gas line through the levee, 3 feet below the crown. Gas line markers visible on the east toe of the levee at the intersection of the levee and Delhi Road. (Permit No. 8151, 1972 - Dow Chemical). [Additional Reference(s): DWR Levee Log, 1992]. FS Date: 8/8/2013

Gasline markers next to old rail road grade, looking south.

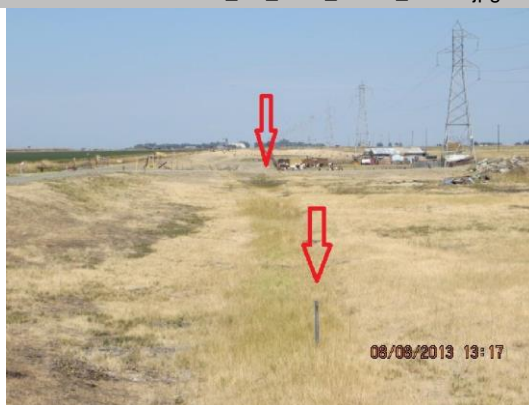
Photo 2 of 2 : UCIP\_SP\_2018\_17531\_29640.jpg

Gasline markers on east side of levee toe looking North.

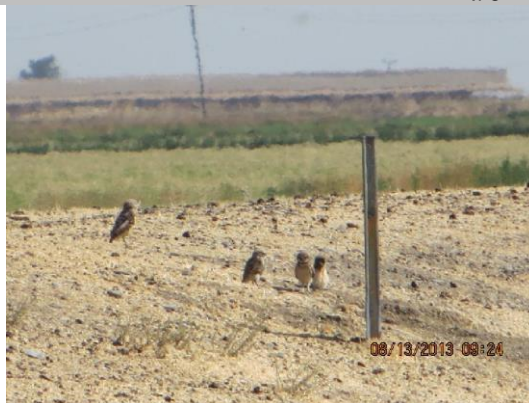
Photo 1 of 3 : UCIP\_SP\_2018\_17532\_29644.jpg

LM Start	1.07	Rating **	M	Issue No.	22
LM End	1.07	Issue Type +	En	Location *	
Category	Supplemental			GPS Latitude/Longitude	
				Start	End
Item	DWR UCIP Field Study			38.373330 °	38.373330 °
				-121.738530 °	-121.738530 °
DWR ID					
Comment Code					
Inspector Comment					
FS_ID:17532 DS_ID:19354 EP_NO: 13028 Repair Type: Non-Urgent Crossing Status: Indicator Found UCIP Comments: Need improved signage on LS and WS shoulders. FIELD_STRUCT_DESC: 10-inch coated steel pipe through the levee, 2 feet below the crown. 4-inch gas line sleeved through the 10-inch pipe. Sign missing from marker post on east slope. 2-inch vent pipe with identification sign off the west bank of the levee and off the toe of the east side of the levee at the fence. (Permit No. 13028, 1980 - Shell Oil Company). FS Date: 8/13/2013

Sign post without markings on WS slope.

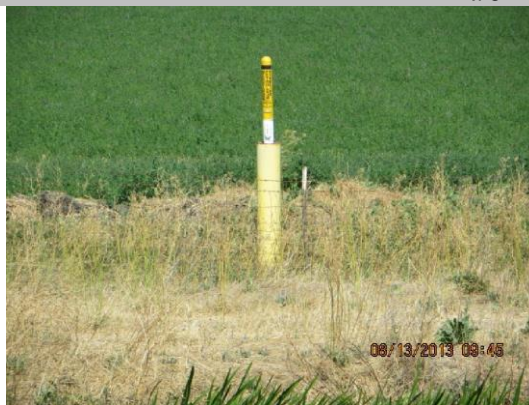
Photo 2 of 3 : UCIP\_SP\_2018\_17532\_29643.jpg

Sign marker off LS toe.

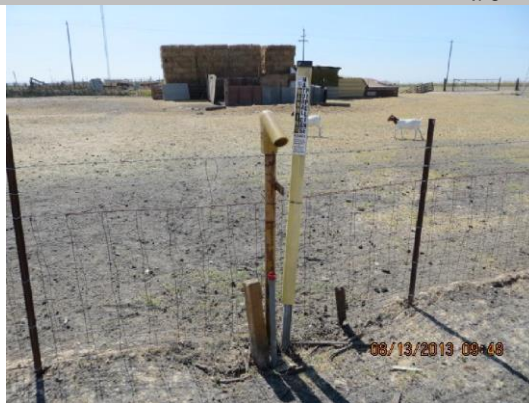
Photo 3 of 3 : UCIP\_SP\_2018\_17532\_29642.jpg

Vent and signage off WS toe.

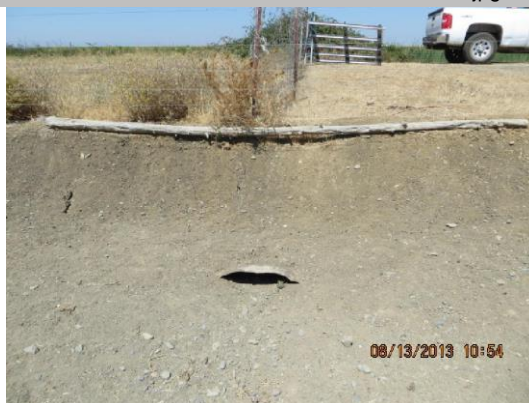
Photo 1 of 1 : UCIP\_SP\_2018\_42725\_29680.jpg

Comment Code					
Inspector Comment					
FS_ID:42725 DS_ID:19352 EP_NO: 10164 Repair Type: Non-Urgent Crossing Status: Found UCIP Comments: 09/14/2017 ABO issued as Permit No. 10164 defines the 48-inch pipe as a drainpipe. (DWR UCIP - O. Magana) 08/13/2013 Appears abandoned and if so should be done properly. Pipe burried except for small opening. (DWR UCIP - W. Wylie) FIELD_STRUCT_DESC: *ABANDONED* 48-inch corrugated metal drainage pipe through the levee, 4 feet below the crown. (48-inch pipe [HLM 3.20]authorized under Automatic Board Order (ABO) issued as Permit No. 10164, 1974 - Reclamation District No. 2068). [Additional Reference(s): DWR Levee Log, 1992. USACE Sacramento O&M Manual 109, April 1962, (HLM 3.20)]. FS Date: 8/13/2013

Pipe buried but visible at toe of east side of levee.
